Les Wilson
Systems Application Engineer

National
Semiconductor

NS16081 FPU As a Peripher

March 84

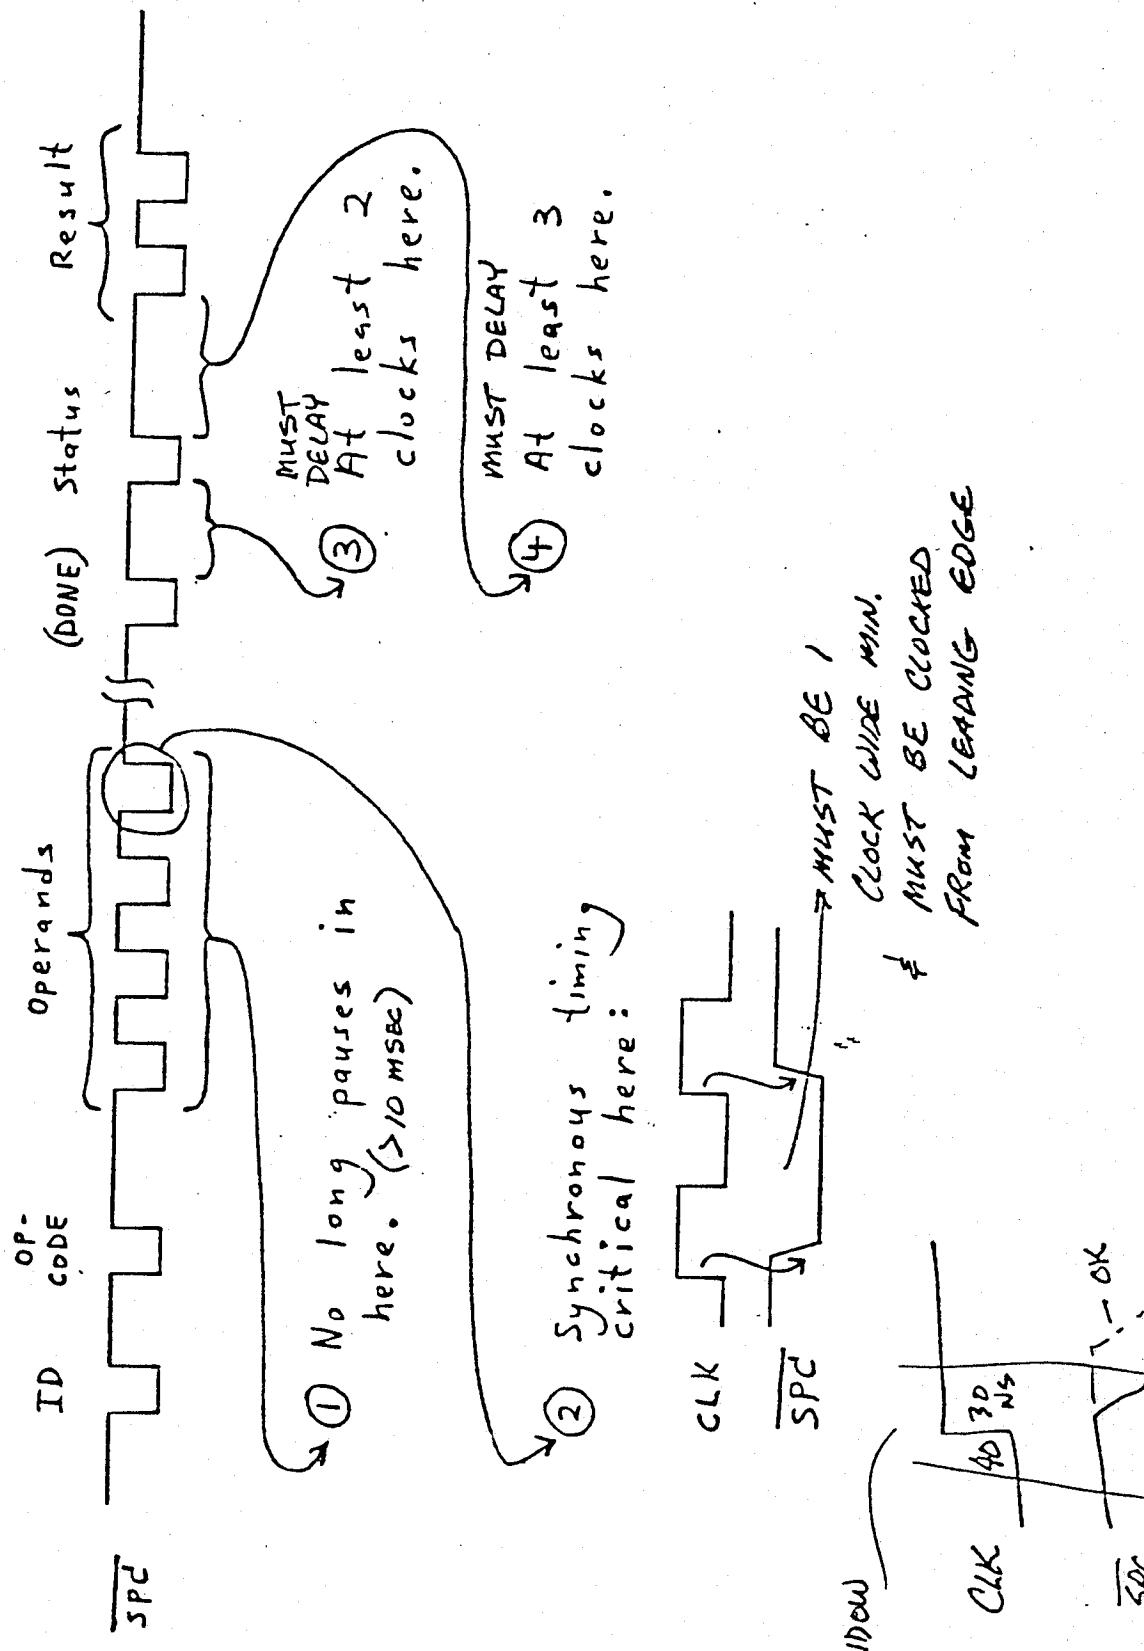
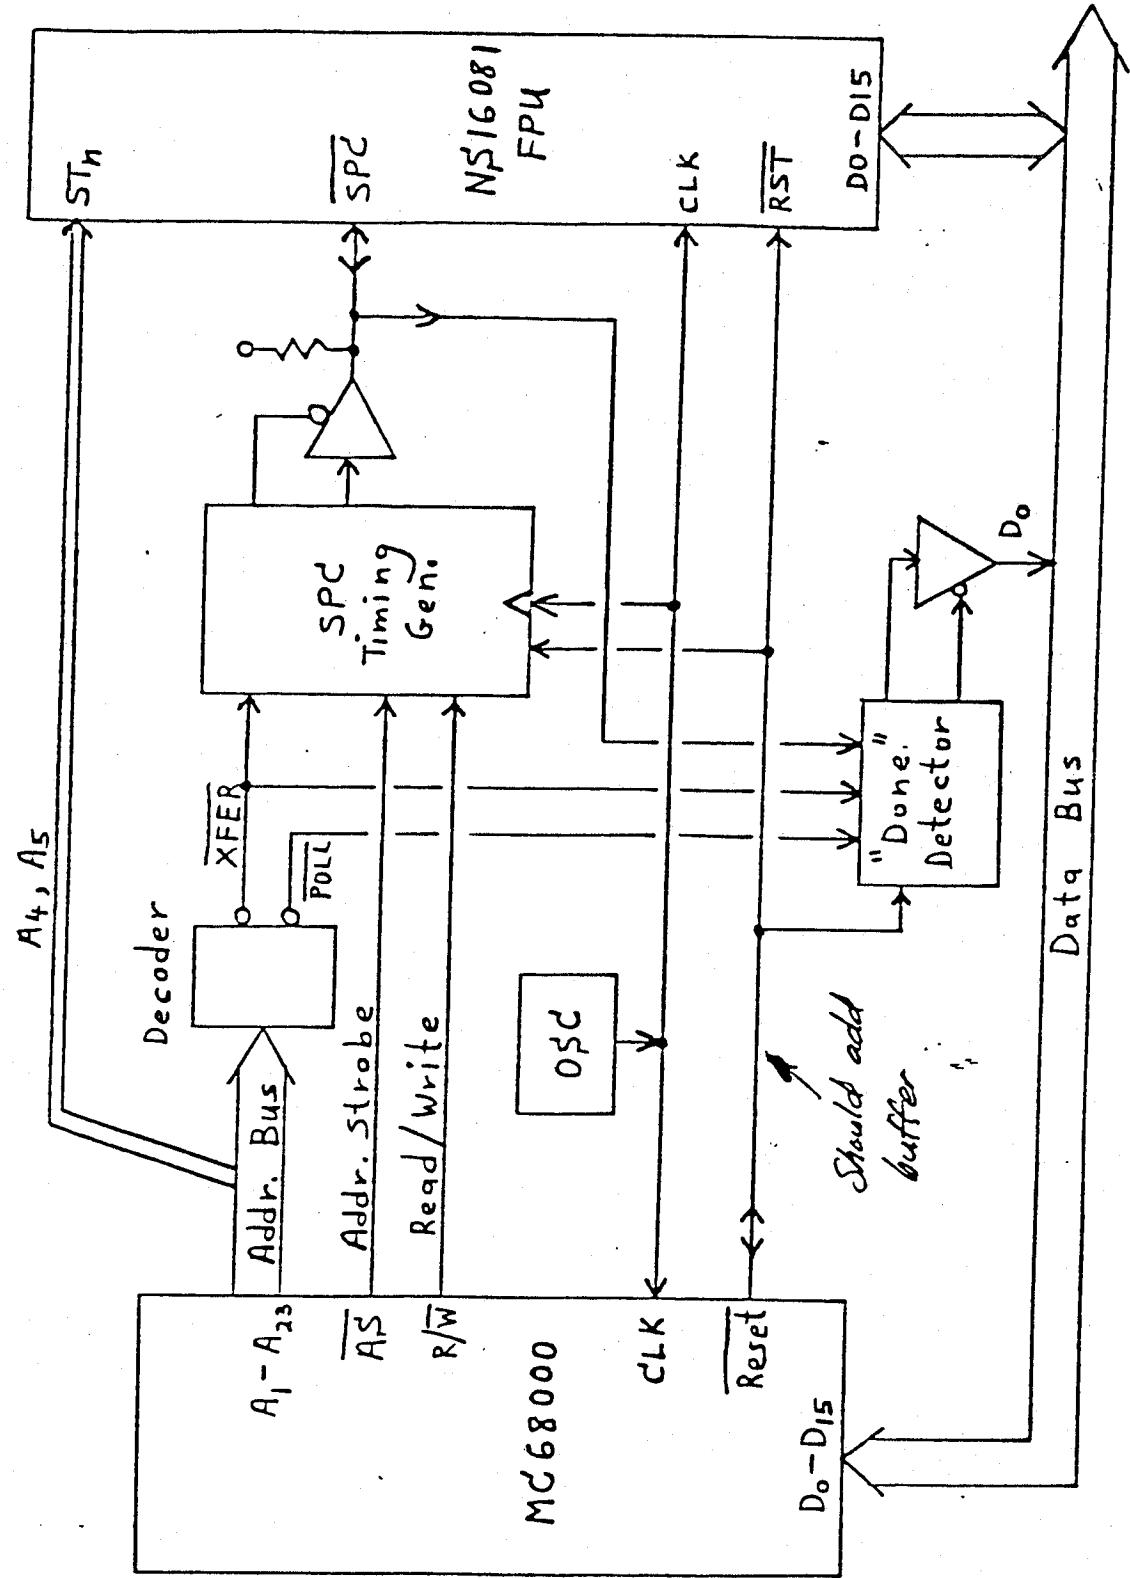
Interfacing to FPU : Cautions

- o In multitasking systems, don't interrupt a half-complete FPU instruction and allow another program to use the FPU. Set a semaphore bit in software while an FPU instruction is in progress. This gives the OS enough information to avoid such problems.
- o Don't use asynchronous SPC pulses.
This is a synchronous interface
- o Don't "single-step" the protocol manually.
(Long pauses cause problems in current FPU revisions.)
